MISSISSIPPI-SALT-QUINCY RIVER BASIN

LOST LAKE DAM
LINCOLN COUNTY, MISSOURI
MO. 10212

**PHASE I INSPECTION REPORT
NATIONAL DAM SAFETY PROGRAM**

SEPTEMBER 1979

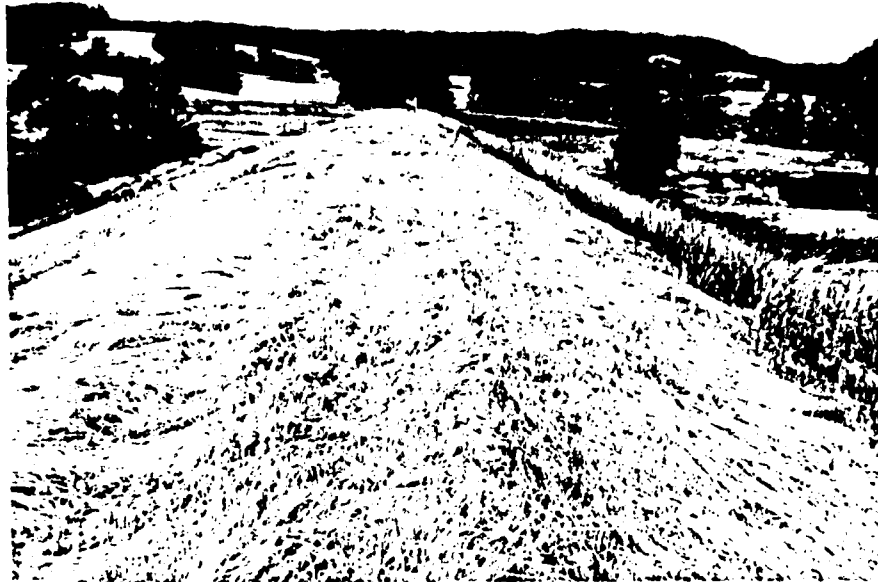
Photo 1

The crest of the dam is well protected against surface erosion by a well maintained cover of grass. There was no evidence of significant settlement or cracking on the crest. No significant deviations in horizontal or vertical alignment were apparent. According to Mr. Robert Glosier, the water level has never been higher than 8 feet up the slope above the principal spillway. Therefore, the emergency spillway has not been used and the dam has not been overtopped.

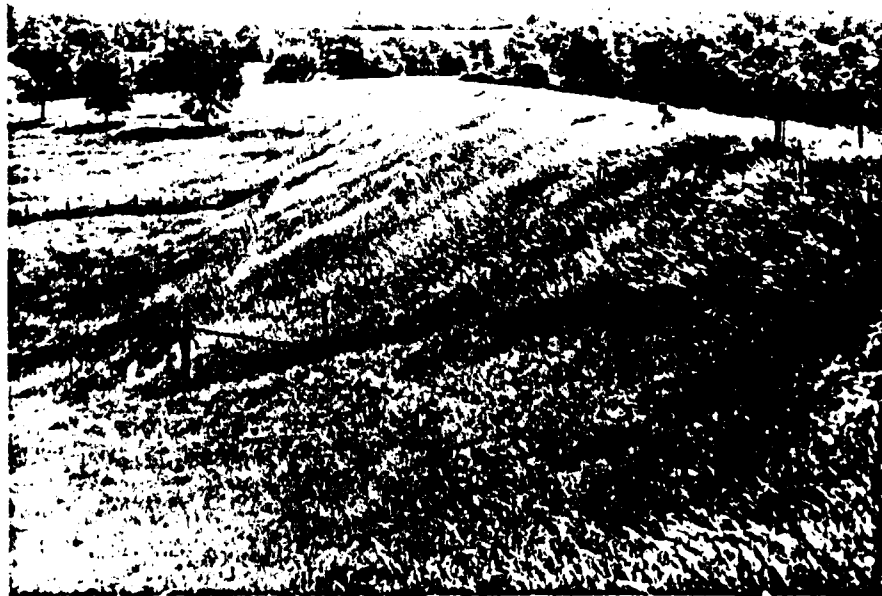
Photo 2

The downstream slope of the embankment has a heavy grass cover. According to Mr. Elmer Glosier, a slide on the slope occurred shortly after construction. The slide area is located on the upper half of the slope and immediately to the right of the principal spillway outlet. The damaged area was approximately 20 to 25 feet wide and did not extend to the crest. The slide was shallow in depth. Some minor erosion was observed on the downstream embankment near the fence on the left abutment. No other depressions, bulges or settlements were apparent on the downstream slope. No seepage was apparent along the toe of the slope. Materials removed

There were no signs of settlement or distress observed on the embankment or foundation during the visual inspection. The slide area on the downstream slope appears to be stable and is not serious enough to indicate an unsafe condition. According to Mr. Elmer Glosier, a professional engineer viewed the slide area shortly after the slide occurred. The professional engineer determined that the damaged area had no significant effect on the overall stability of the slope and that the slope had stabilized. According to Mr. Elmer Glosier, no other slides have occurred on the slope.

The slide area on the downstream embankment slope has stabilized and was determined by a professional engineer to pose no danger to the stability of the downstream slope. No other signs of distress were observed in the embankment or in the foundation, nor was seepage observed at any location. No seepage and stability analyses were available for review.
